# Buildings left standing in Turkey offer design guidance for future earthquake-resilient construction

By [Osman Ozbulut](#)

5 Apr 2023

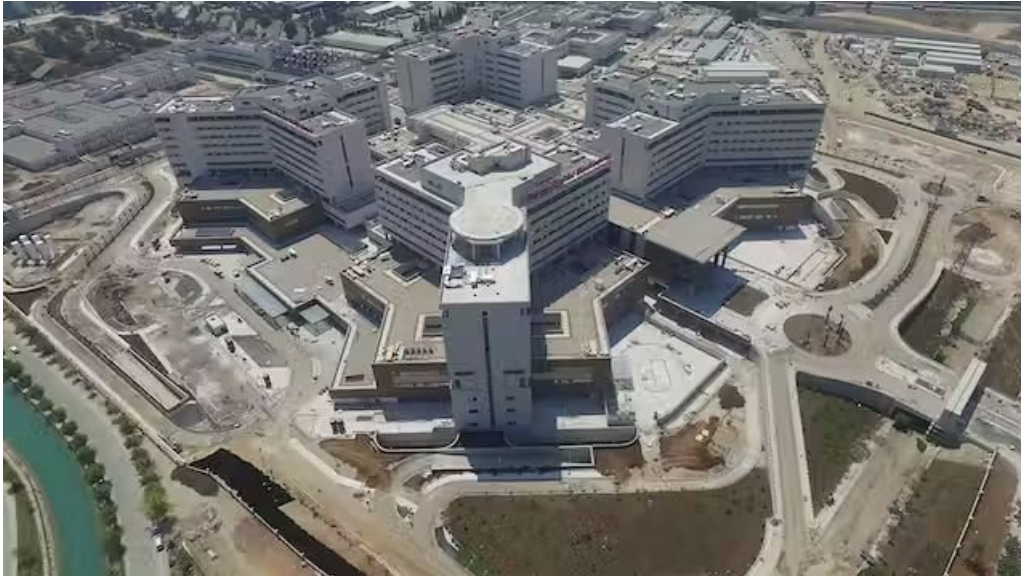
Turkey's Adana Hospital survived the February 2023 earthquakes with no damage because of its seismic isolation system  
Earthquake Protection Systems, Inc., CC BY-ND

Adana City Hospital was built to record both ground shaking and the building's response. Thanks to its seismic isolation system, the building saw a 75% [reduction in shaking](#), according to the company that designed the isolation system, compared with neighbouring structures. This system allowed the building to stay up and running after the earthquake.

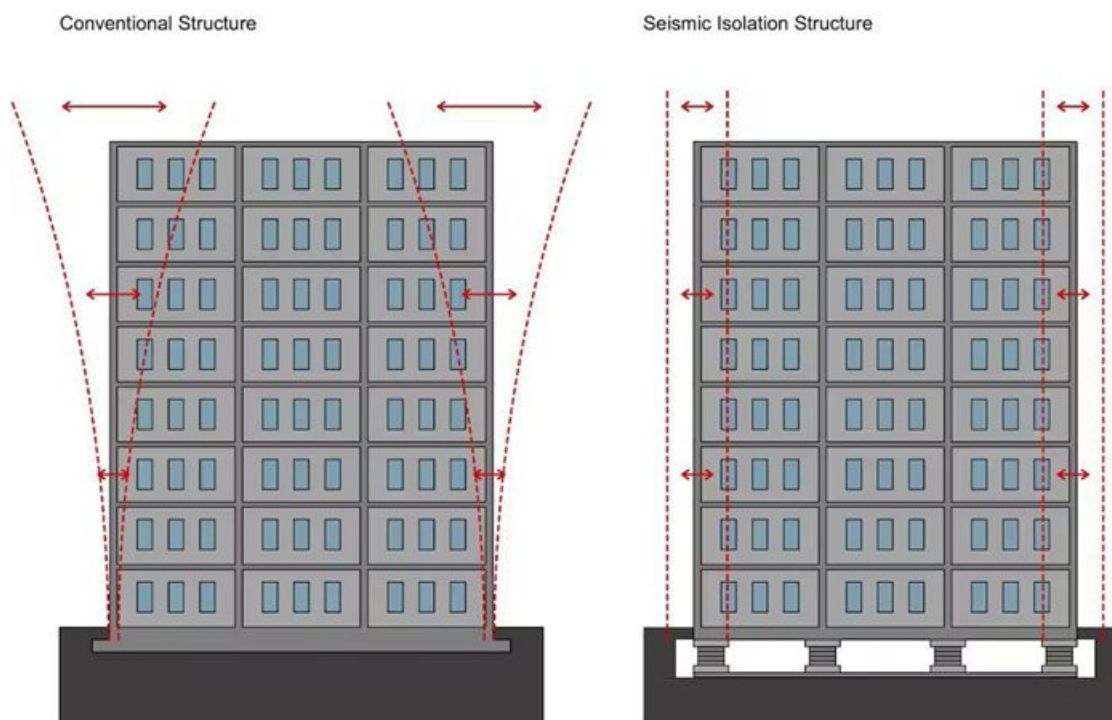
The left shows a building without seismic isolation, while the right image shows a building with a seismic isolation system which minimises how much damage the building sustains during an earthquake. The red lines denote how much motion the building could experience during an earthquake. Ozbulut Lab, CC BY-ND

[Seismic isolation systems](#) prevent seismic energy from entering buildings in the first place by using devices made from rubber or steel plates coated with a friction-generating material that slide over one another to minimise an earthquake's impact. These isolation devices are installed between the building's foundation and the building itself. Alternatively, seismic dampers, installed in each story of a building, absorb earthquake energy the way shock absorbers work in a car and convert it into heat energy to [minimise damage](#).
